LIQUID HYDROGEN POSITIVE EXPULSION  
BLADDERS

Contract NAS 3-11192

THE BOEING COMPANY

FINAL REPORT

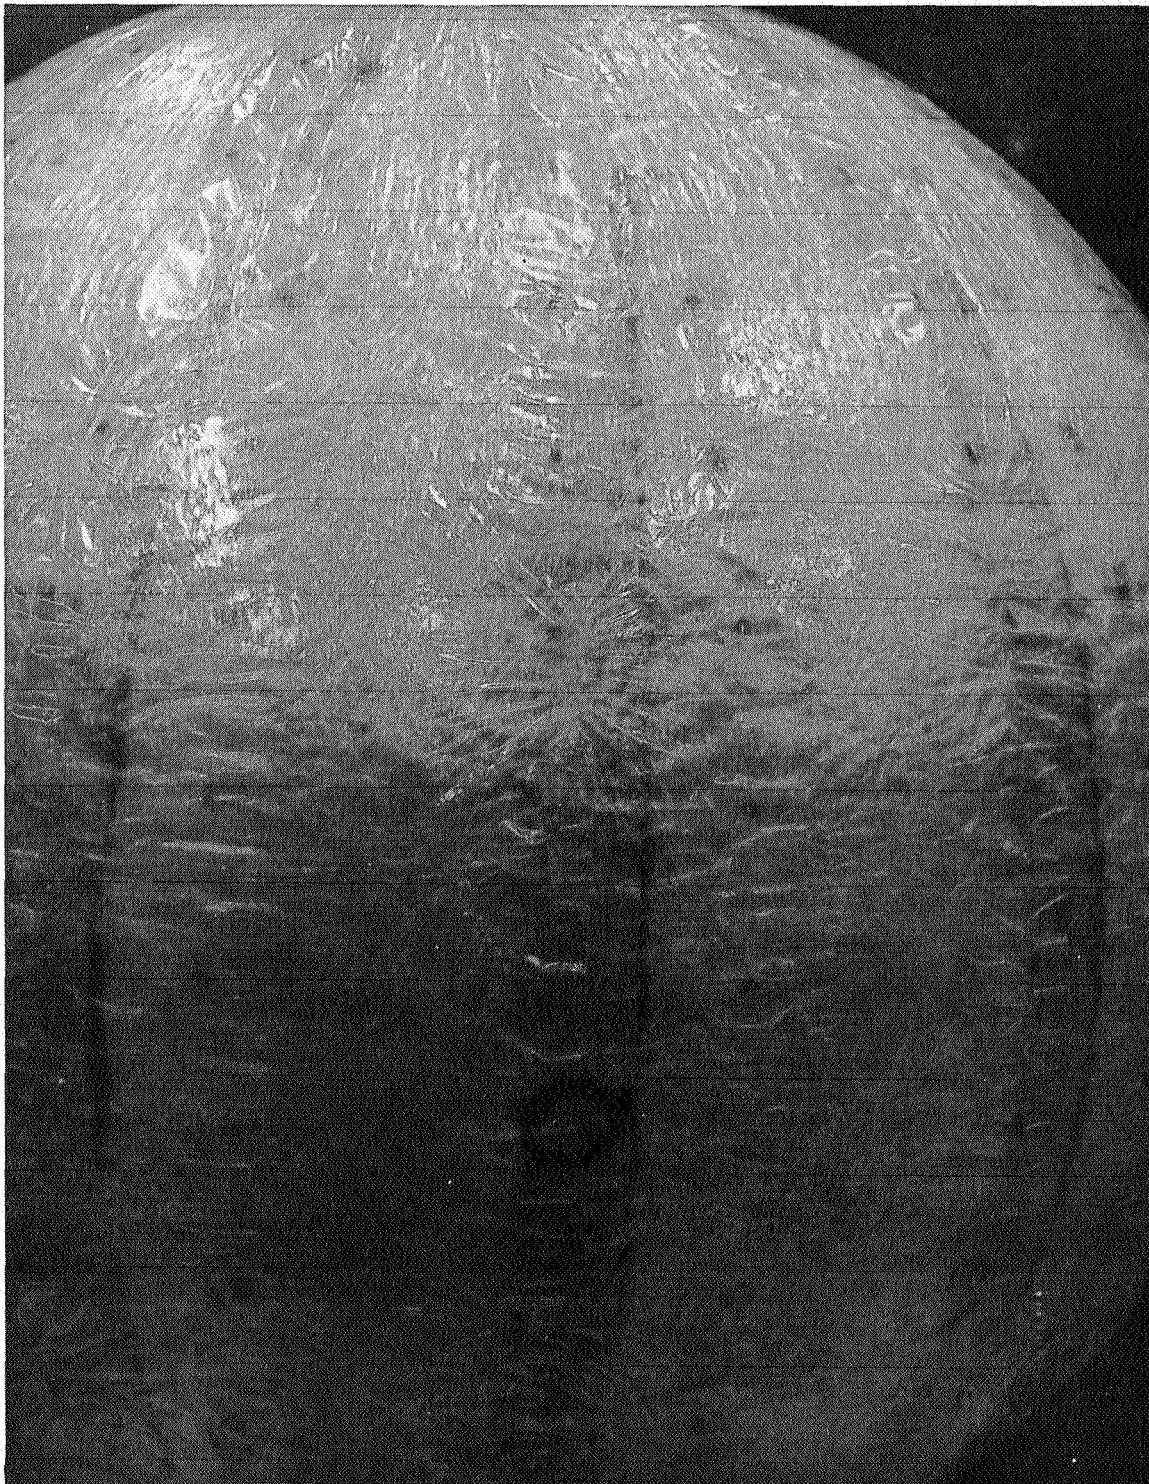
The bladder was quite stiff and hard. It was necessary to compress the bladder diameter at the attachment stem by hand in order to fit the bladder down the neck of the test dewar. The initial  $-423^{\circ}\text{F}$  helium porosity rate was 37.1 cc/min.

FIGURE 15 BLADDER 50-X-10-0, SHCWINING POOR SEAMS AND  
FILM WRINKLING

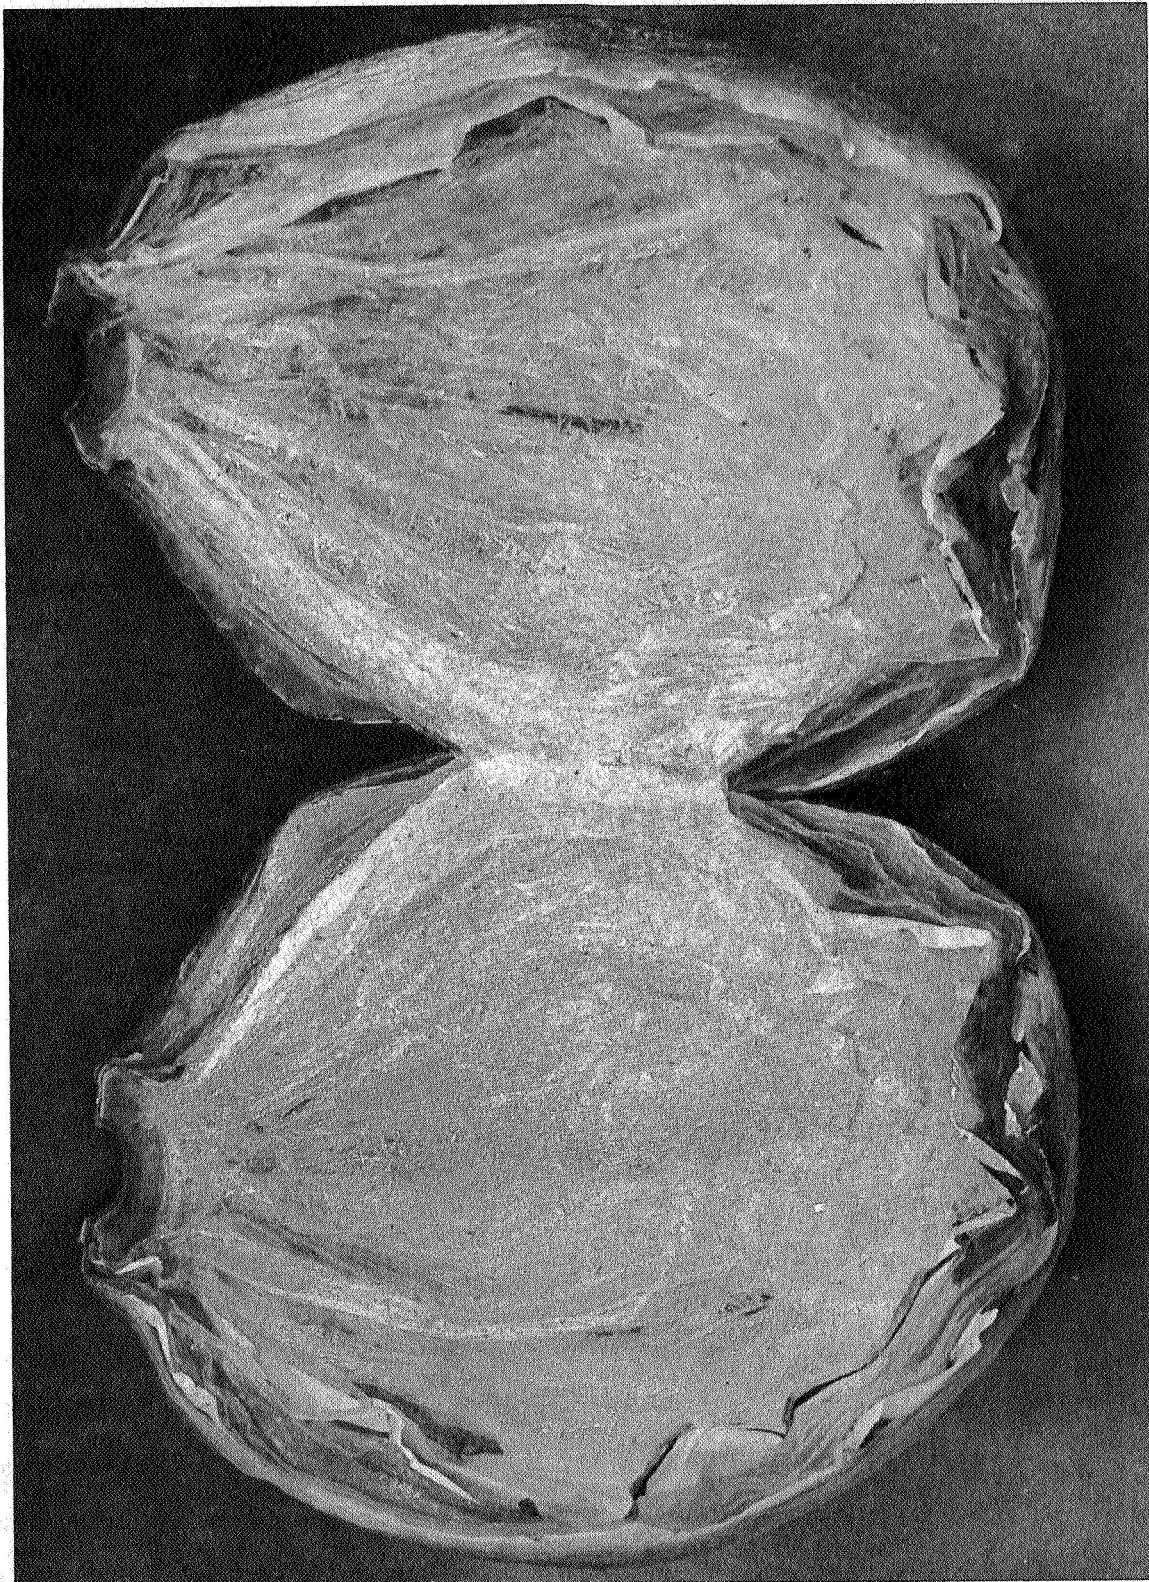
The ply-by-ply examination of the dissected bladder revealed a highly stretched area in Ply No. 1, possibly caused by pressing the film against the

FIGURE 16 BLADDER 50-X-10-0, SHOWING INTERNAL FOLDS AND PLY SEPARATION

helium fill tube, and a 2 inch long tear associated with a very tight fold. Ply No. 2 had no holes but did have about 1 inch of open seam next to a high-stretch area. Plies 4 through 8 had no holes but the lap bond quality was poor. Ply No. 10 had a 45° angle tear across one gore at the equator of the bladder and an open seam 3 inches long at the top of the bladder. Ply No. 11 had no holes or obvious flaws, nor did No. 13. The in-between ply No. 12 had a 0.5 inch long hole in one gore at the equator of the bladder, and the south polar cap consisted of one ply of No. 3711 film and one ply of Mylar. The outer ply No. 14 had 9 small holes adjacent to the stem attachment. The holes in this bladder were not tears but resembled flexural fatigue failures.
